**Expert Report of  
Timothy Myers, Ph.D., CFEI**

**Marcellin, et al. v. HP, Inc. and Staples, Inc.**

**December 2, 2024**

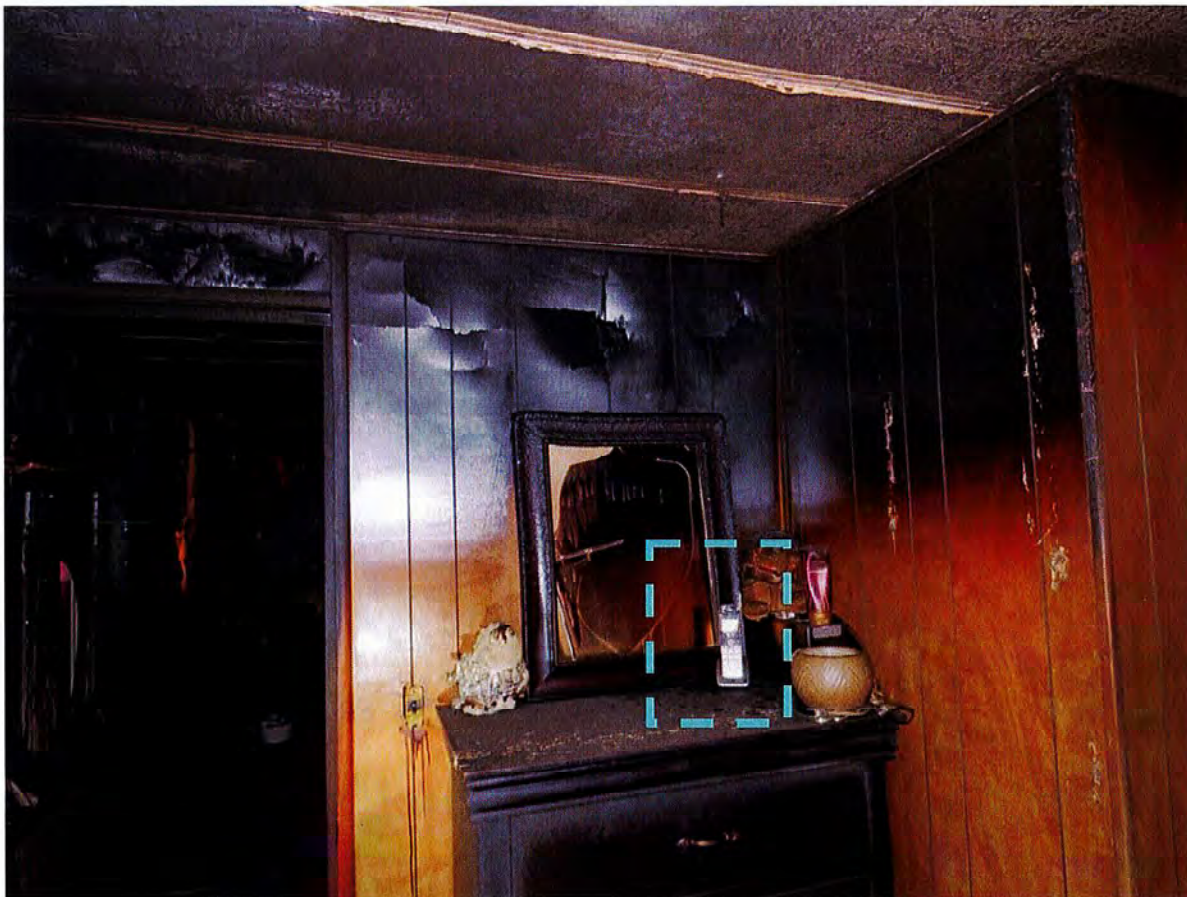
Figure 5. Photograph shows a cordless phone in its charging station in the spare bedroom. The light blue box annotated by Exponent highlights the phone's location.<sup>30</sup>

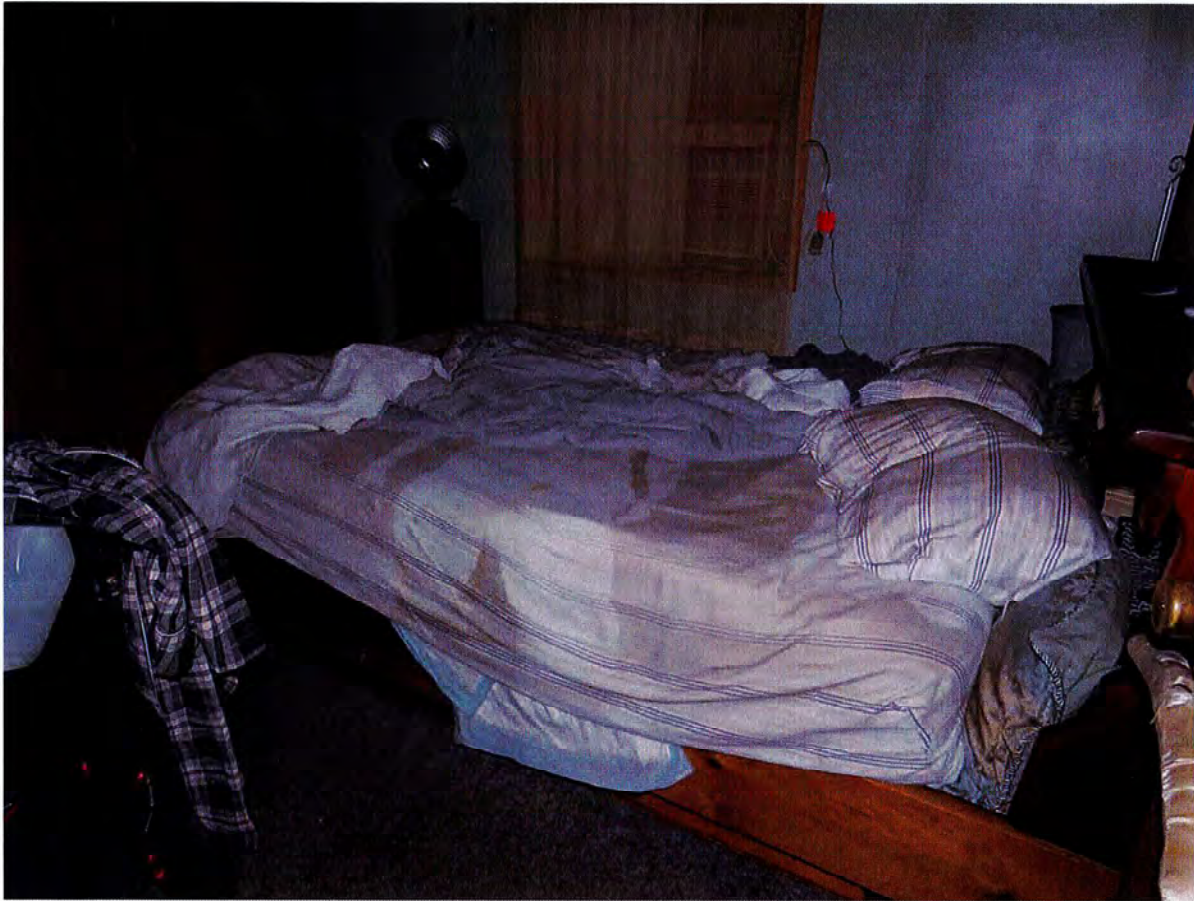
Figure 6 and Figure 7 show photographs of the primary bedroom taken by Allegany County fire investigators. The photographs show a protected region on the bedsheets that is visible because soot accumulated on the bed in areas that were not covered during the fire. The protected area is consistent with the shape of a body lying crosswise on the bed during the fire. This is consistent with the description of where first responders found Mr. Hollowell and is not consistent with Ms. Marcellin's testimony that he was on the floor and would not be able to get onto the bed.

Figure 6. Bed and wheelchair (bottom left corner) in primary bedroom. A protected region is visible on the sheets consistent with a body lying crosswise on the bed during the fire.<sup>42</sup>

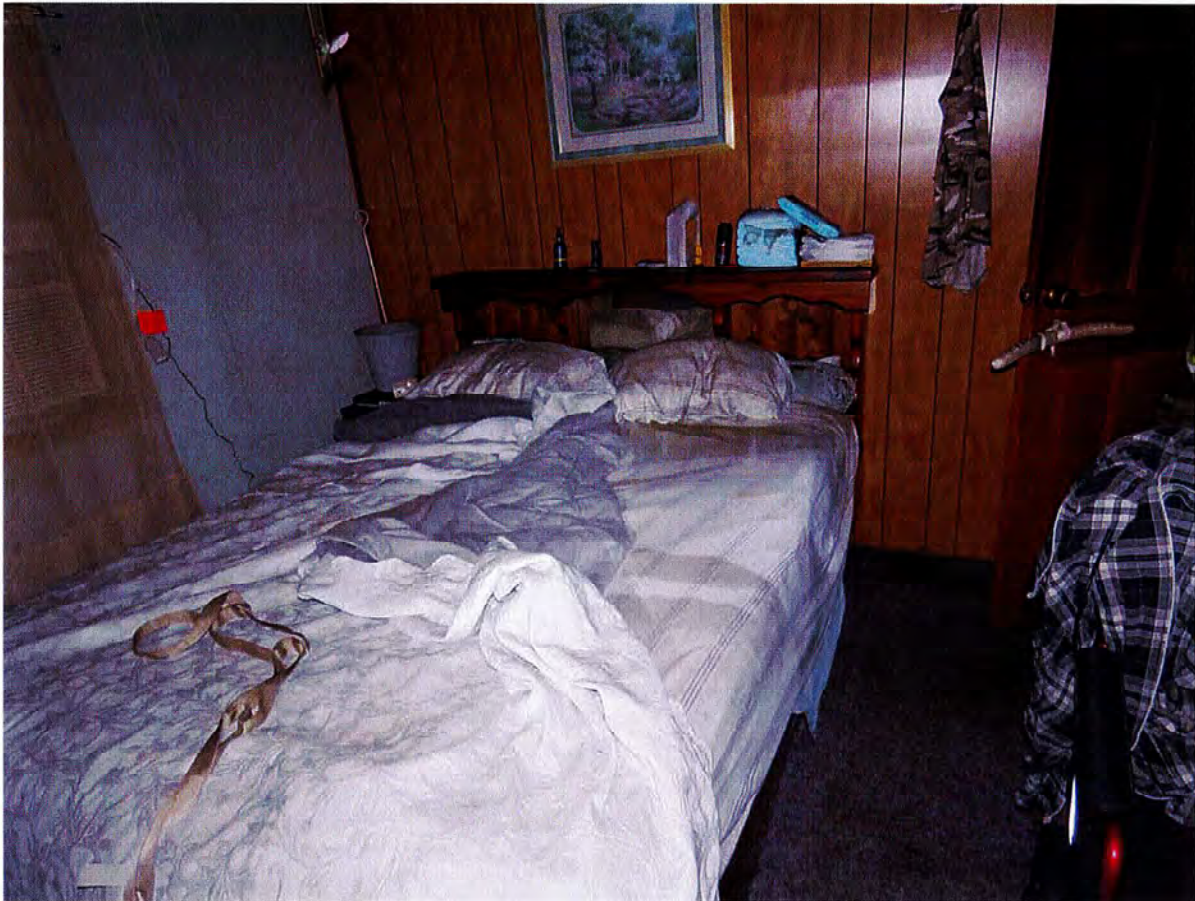
Figure 7. Bed and wheelchair (bottom right corner) in primary bedroom. A protected region is visible on the sheets consistent with a body lying crosswise on the bed during the fire.<sup>41</sup>

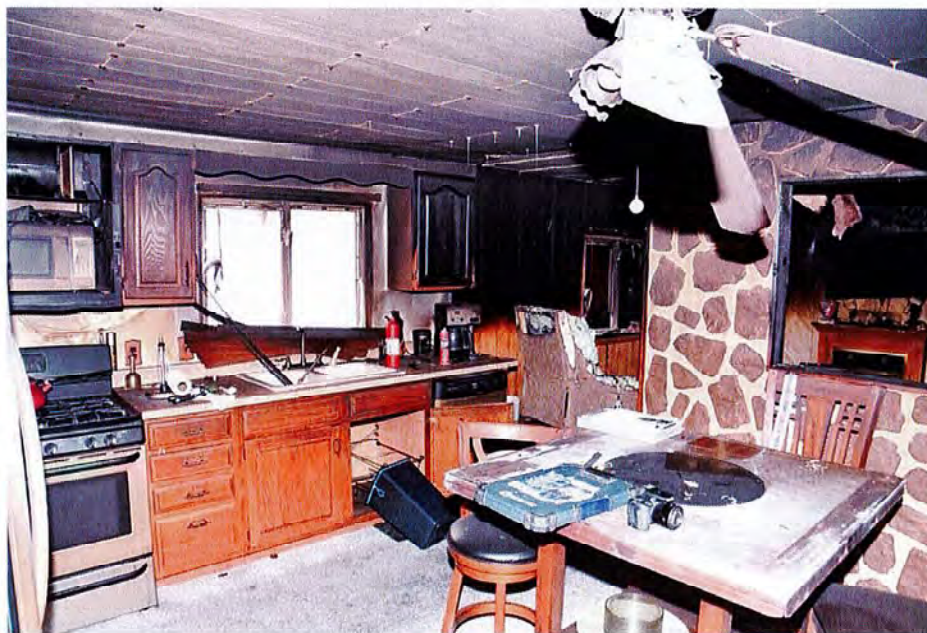
Figure 9 and Figure 10 display photographs of the kitchen in the incident residence. The kitchen experienced heat damage with soot/smoke deposition observed in the upper half of the room, consistent with smoke accumulation at the ceiling. Radiant heat from hot gasses present in the smoke layer also caused the melting of the ceiling fan blades, as pictured in Figure 9. Upon entering the kitchen, first responder Beaton observed the toaster oven glowing and unplugged it.<sup>44</sup>

Figure 9. Photograph of the kitchen in the incident house.<sup>45</sup>

Figure 10. Photograph of the kitchen in the incident house.<sup>46</sup>

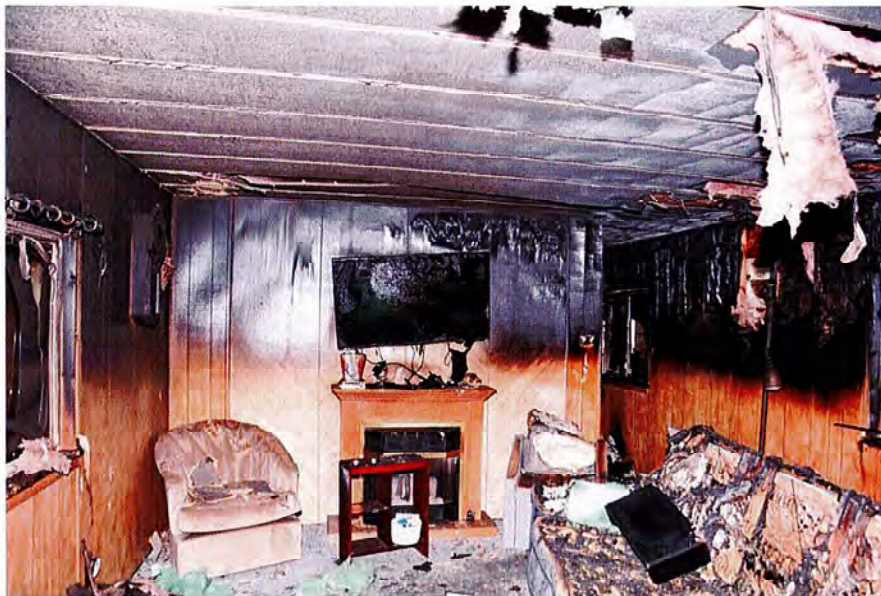
Figure 11 and Figure 12 provide photographs of the living room in the incident house. As highlighted in the figures, there is a demarcation line on the living room walls approximately halfway down from the ceiling. Lines of demarcation represent the lower extent of the hot gas layer that forms on vertical surfaces. There is also charring observed on parts of the ceiling and television. The couch in the living room also experienced significant heat damage, with substantial loss of material and charring; it is the lowest burn area in the living room. Damage to the ceiling and wall near the couch is consistent with first responder statements about observing and extinguishing hot spots near the couch.<sup>47</sup>

Figure 11. Photograph of the living room.<sup>48</sup>

As provided in Figure 11, there was an electric fireplace located in the living room, sharing a wall with the office. The thermal damage on the wall in the living room behind the fireplace does not support the fireplace as being the ignition source (i.e., there is no charring present in or around the fireplace).<sup>78</sup>

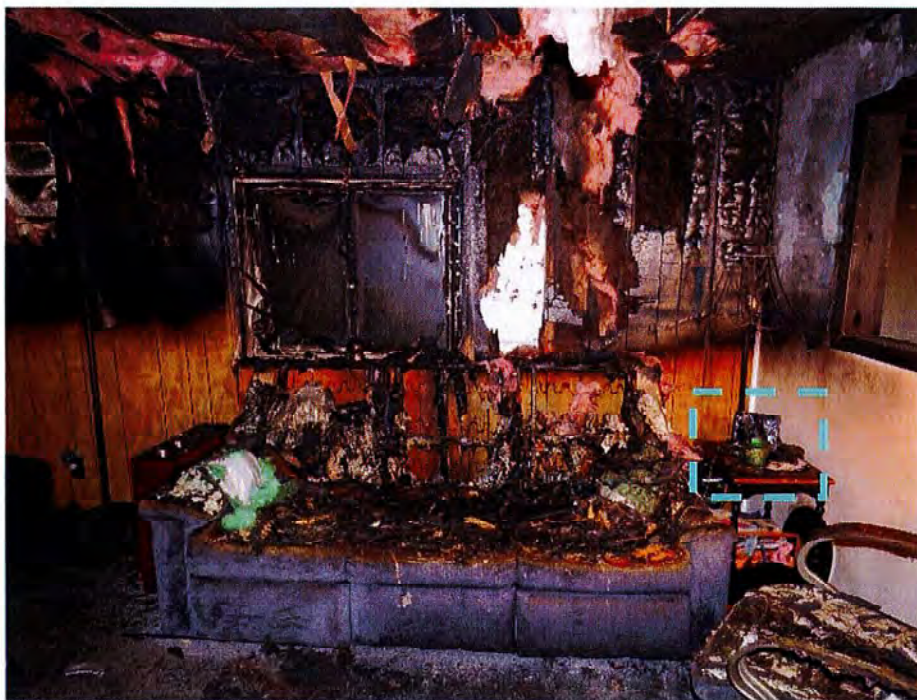
Figure 12. Photograph of the couch in the living room.<sup>49</sup> Note that a candle is present on the table to the right of the couch, highlighted by Exponent in blue.

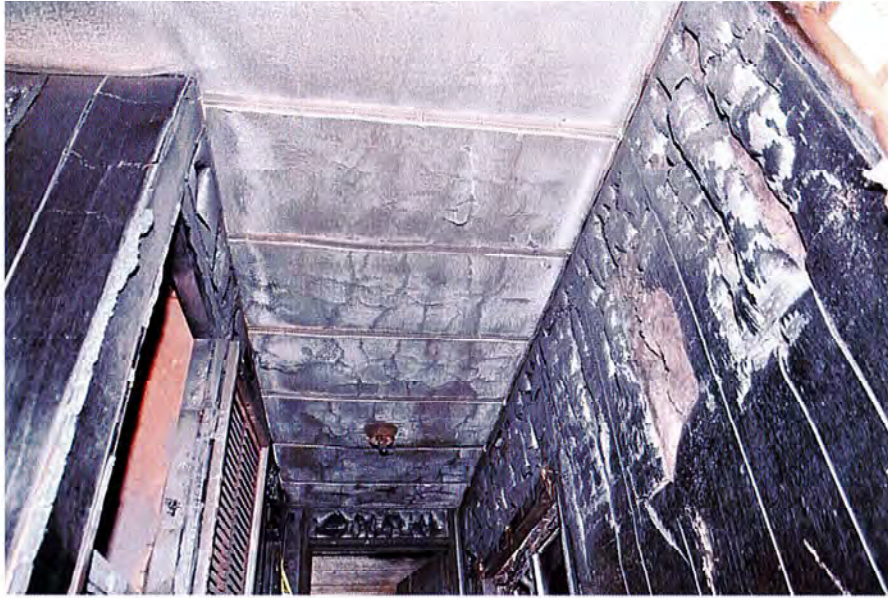
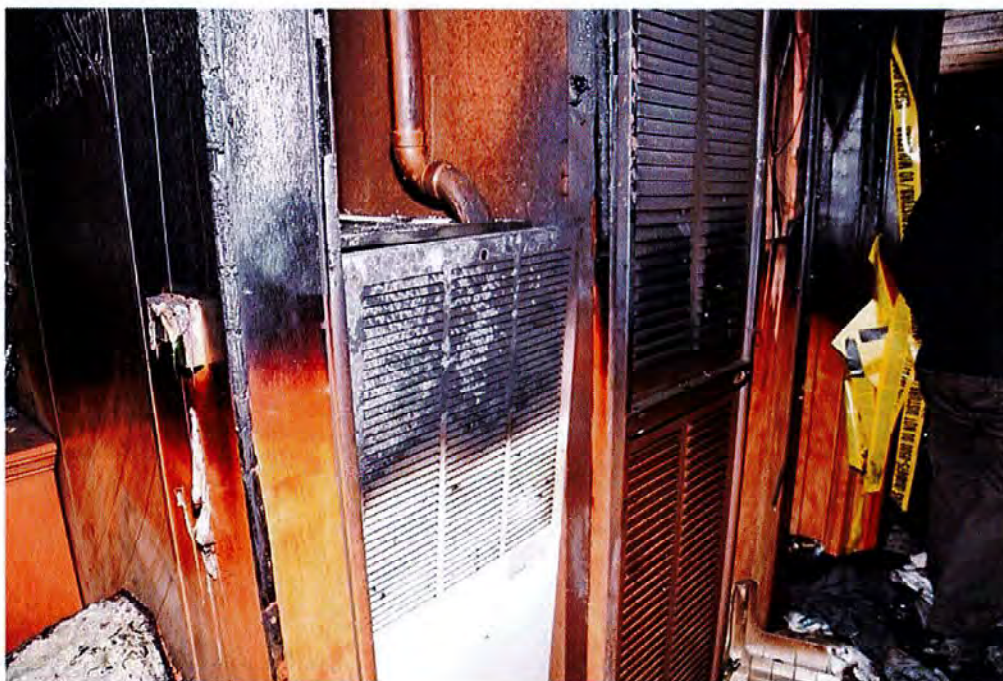
Figure 13 and Figure 14 provide photographs of the ceiling and sides of the hallway, including the furnace space, located at the end of the hallway leading into the living room. Similar to the living room the hallway has a demarcation line extending halfway from the ceiling; charring is also evident on the sidewalls. The furnace also shows heat damage with soot and smoke deposition evident on its exterior. As pictured in Figure 14, the louvered door to the furnace closet is open, and the furnace grill itself is displaced outward at the top, consistent with first responder Greenwald's statement that the furnace was "blown out."<sup>50</sup>

Figure 13. Photograph of the ceiling in the hallway between the living room (behind) and office (on the left).<sup>51</sup>

Figure 14. Photograph of the furnace and hallway between the living room (behind) and office (on the left).<sup>52</sup>

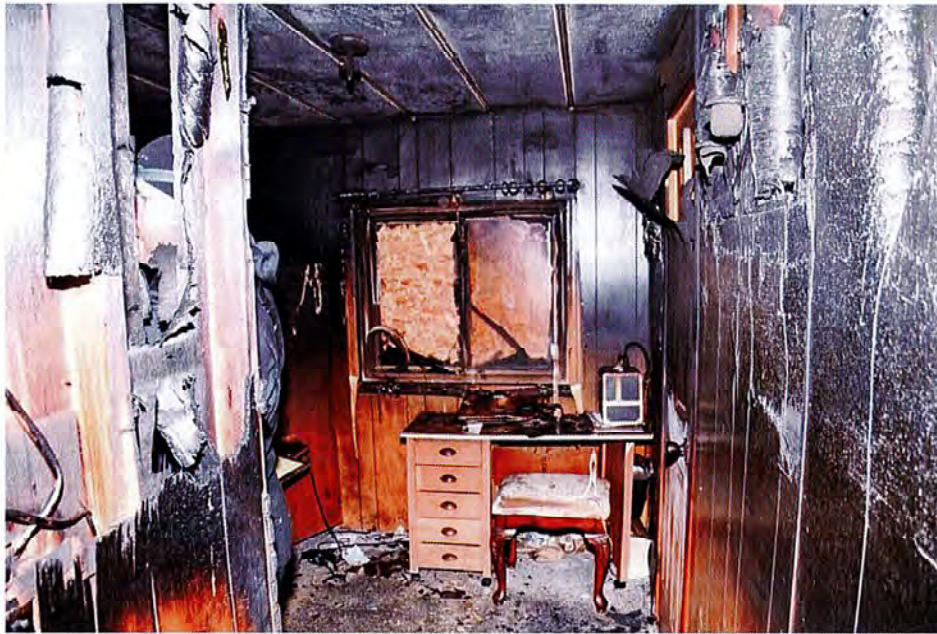
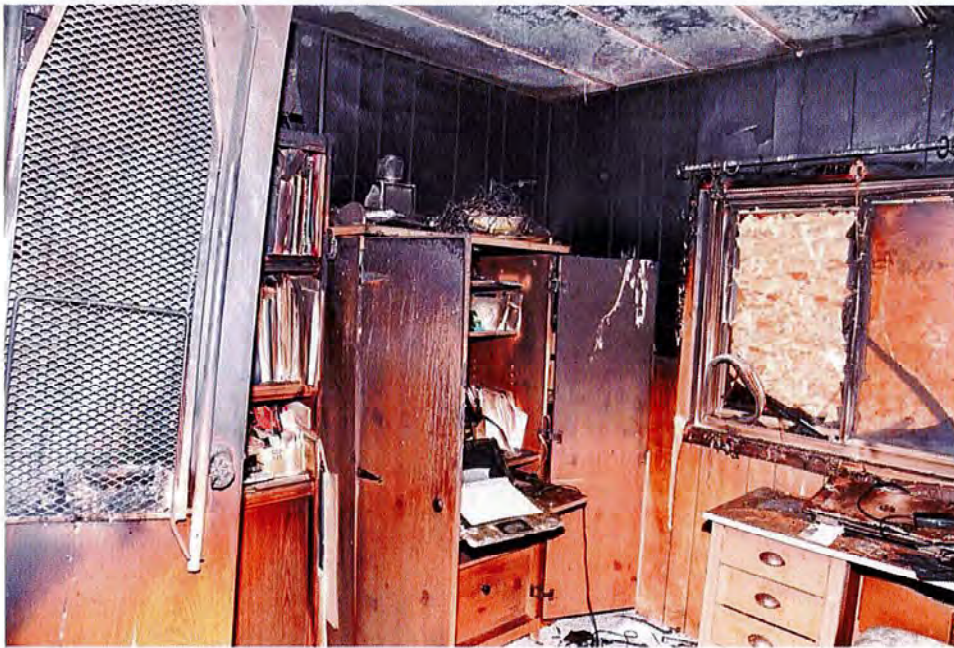
Figure 15 and Figure 16 provide photographs of the office in the incident house. Similar to the living room and hallway, the office also has a demarcation line extending halfway from the ceiling and charring on the side walls close to the office entrance. Section 3.2 provides a more detailed discussion of the damage observed in the office.

Figure 15. Photograph from the office entrance in the incident house.<sup>53</sup>

Figure 16. Photograph of the office in the incident house.<sup>54</sup>

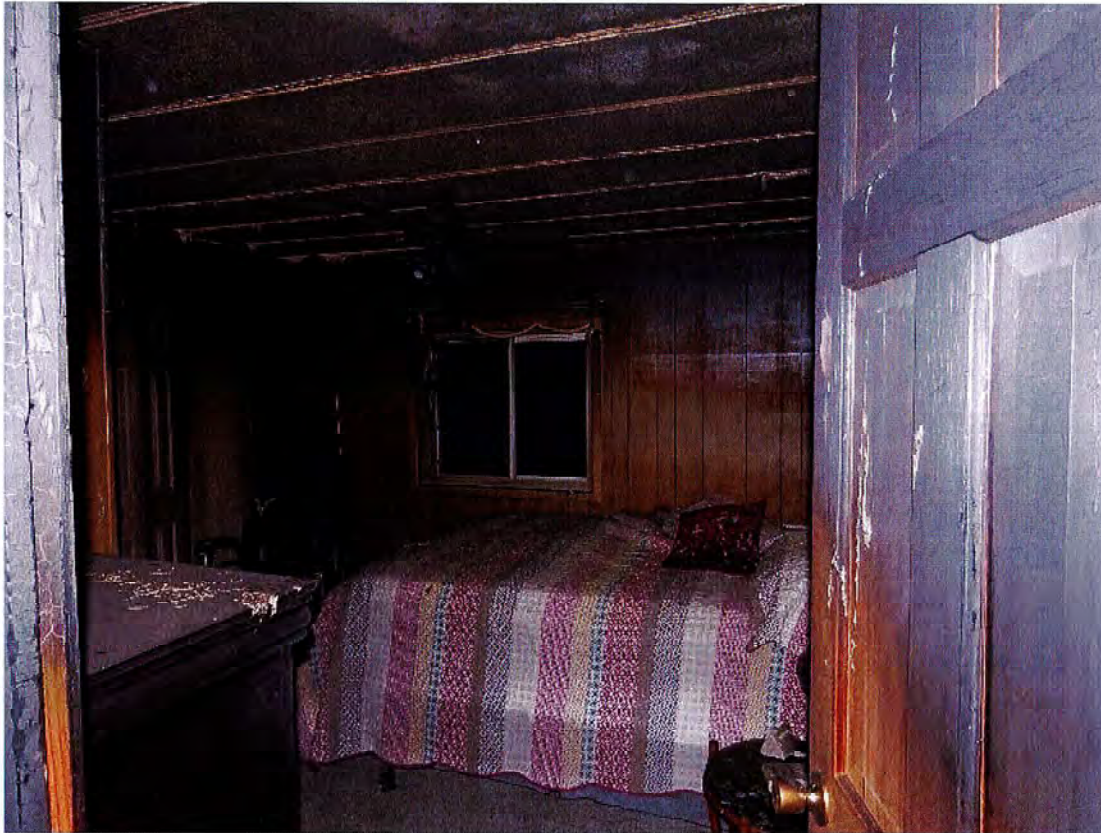
Figure 17 provides a photograph of the spare bedroom, located at the end of the hallway connected to the living room. This bedroom experienced some heat damage with soot and smoke deposition present in the ceiling and upper area of the room.

Figure 17. Photograph of the spare bedroom.<sup>55</sup>

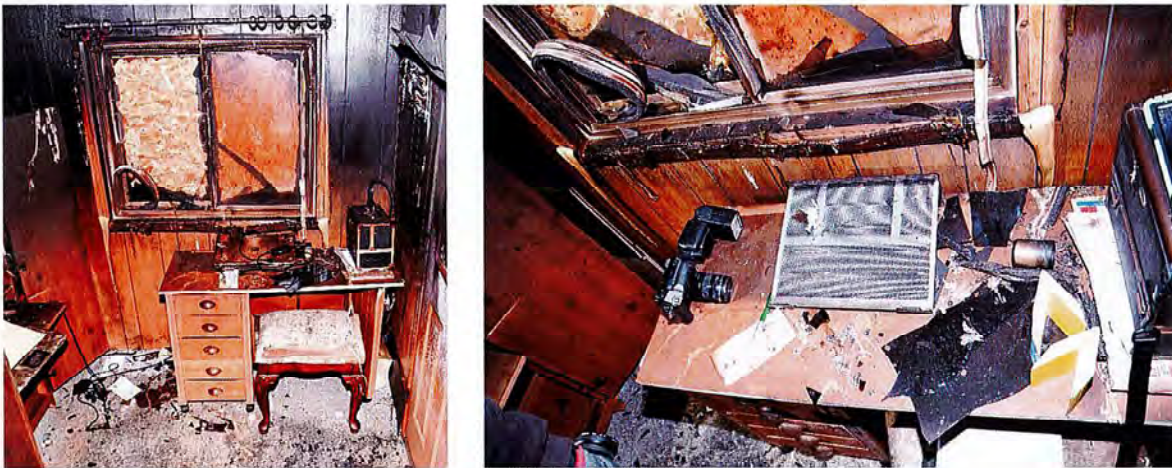
Figure 18 provides photographs of the desk in the office space, which can be seen from the office doorway; this is where the second notebook was located. The desk and the carpet underneath exhibit minimal heat damage. Therefore, it is unlikely that the fire initiated in this location.

Figure 18. Photographs of the desk (sewing area) in the office space.<sup>57</sup>

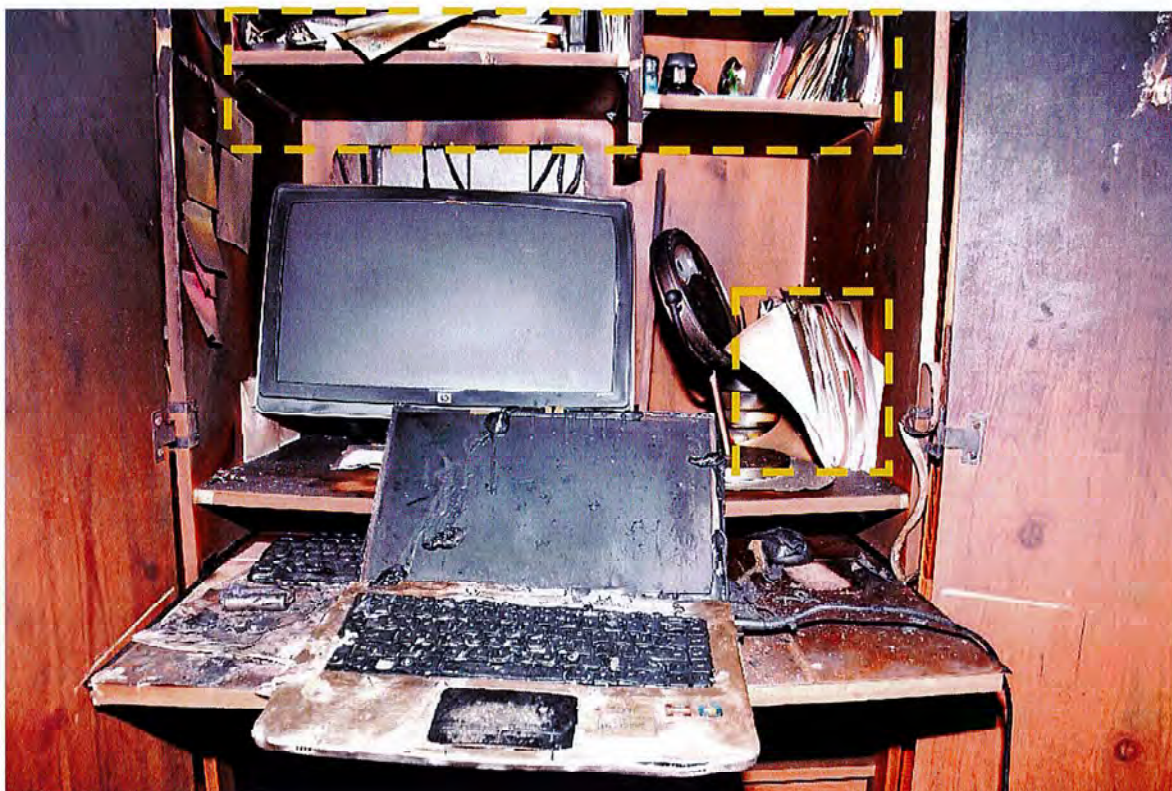
Figure 19 and Figure 20 display photographs of the armoire in the office. The armoire doors have smoke and soot deposition extending almost halfway through its height, consistent with the smoke and soot damage on the walls in the office. The incident notebook on the armoire also shows heat damage to the keyboard and softening and dripping of plastic surrounding the notebook screen. This damage is consistent with radiant heating from a hot layer of gases above. The items present in the armoire display some heat damage consistent with what is expected from hot gas exposure. As highlighted by the boxes in Figure 19 and Figure 20, the light-weight fuel (e.g., sheets of paper) in the armoire has little thermal damage. This suggests that these items were partially shielded from the hot gas layer by the armoire itself. Had the fire originated in or below the armoire, it is likely that these fuels would have been consumed or exhibited greater thermal damage. In contrast, Ms. Marcellin remembers that the armoire and the wall behind it had the most fire.<sup>58</sup> This testimony is not consistent with the physical evidence after the fire.

Figure 19. Photograph of the armoire in the office. The blue dashed boxes are annotated by Exponent to highlight unconsumed light-weight fuel present in the armoire.<sup>59</sup>

Figure 20. Close-up photograph of the armoire in the office. The yellow dashed boxes are annotated by Exponent to highlight unconsumed lightweight fuel present in the armoire.<sup>60</sup>

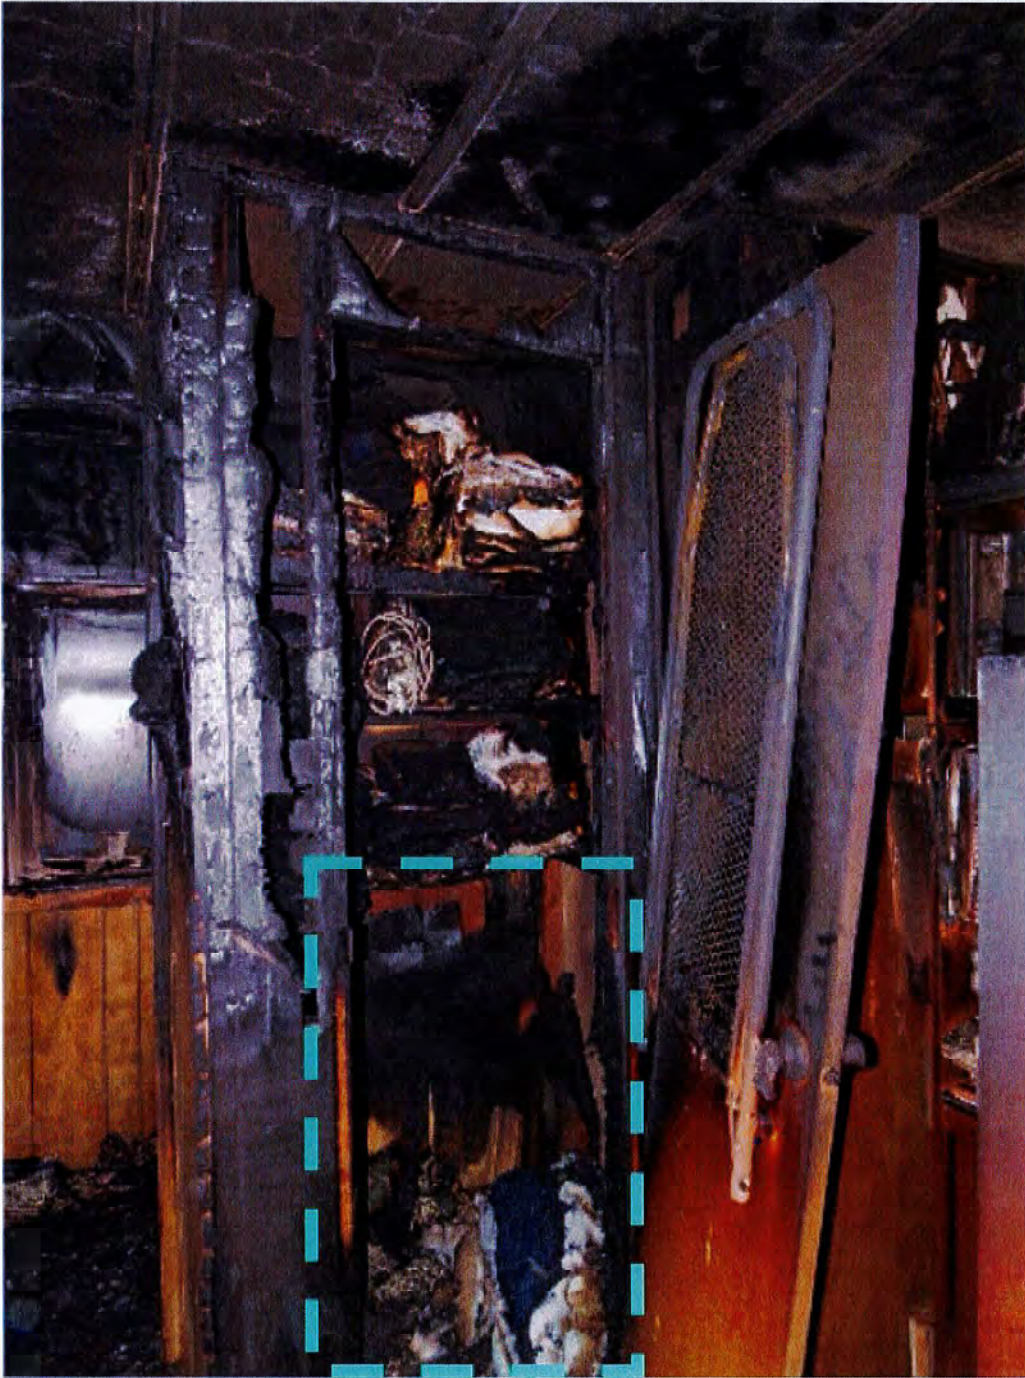
Figure 22 provides a photograph of the office closet, which experienced substantial heat damage and mass loss. The lower section of the closet, highlighted by the blue box, shows areas of damage to the closet walls and fuel consumption. Similarly, fuel present in the upper sections of the closet appears to be at least partially consumed. It is probable that the fire started in or near the closet, as this area of the office experienced the most significant thermal damage and loss.

Figure 22. Photograph of the closet present in the office. The box annotated by Exponent to highlight the heat damage present in the lower section of the closet.<sup>62</sup>

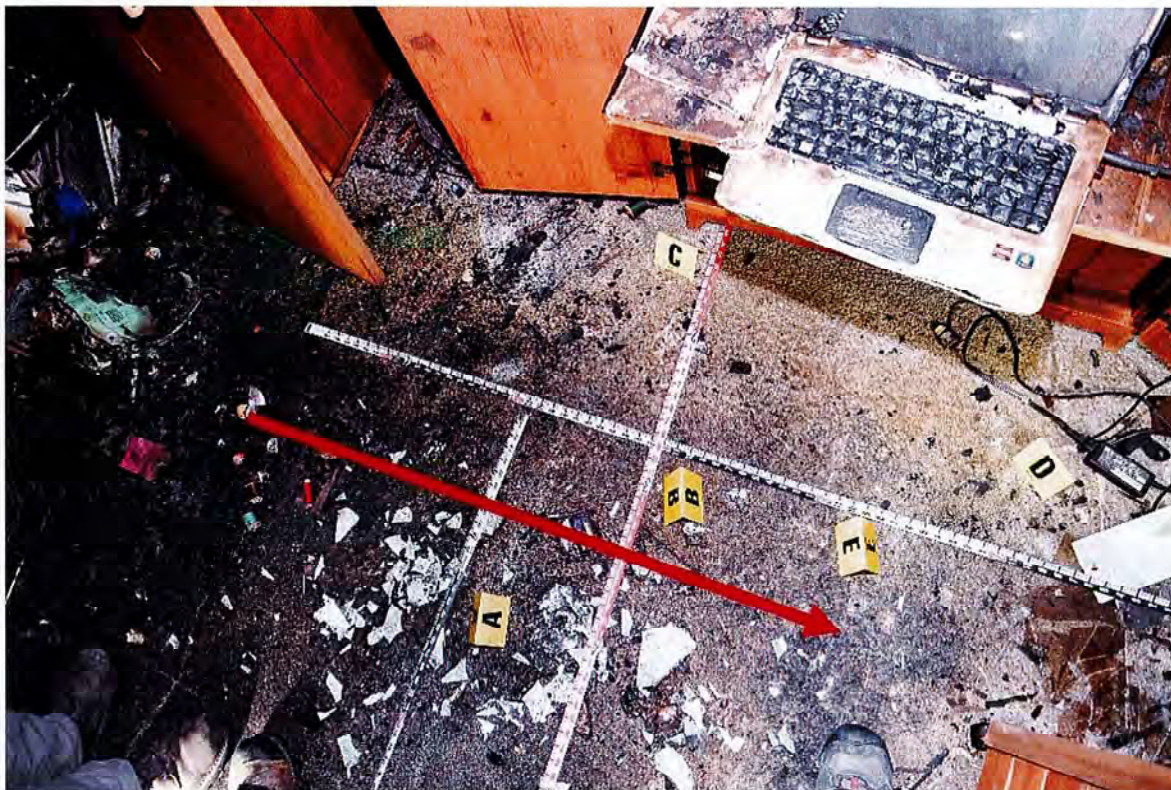
Figure 23 displays a photograph of the carpet between the closet and armoire area. The red arrow is oriented from most to least damage, supporting the observation that the fire spread from the closet to other areas in the office.

Figure 23. Photograph of the carpet nearby the closet and armoire highlighting more damage closer to the closet. The red line annotated by Exponent highlights that the heat damage to the carpet is extensive closer to the closet and reduces as you move further away from it.<sup>63</sup>

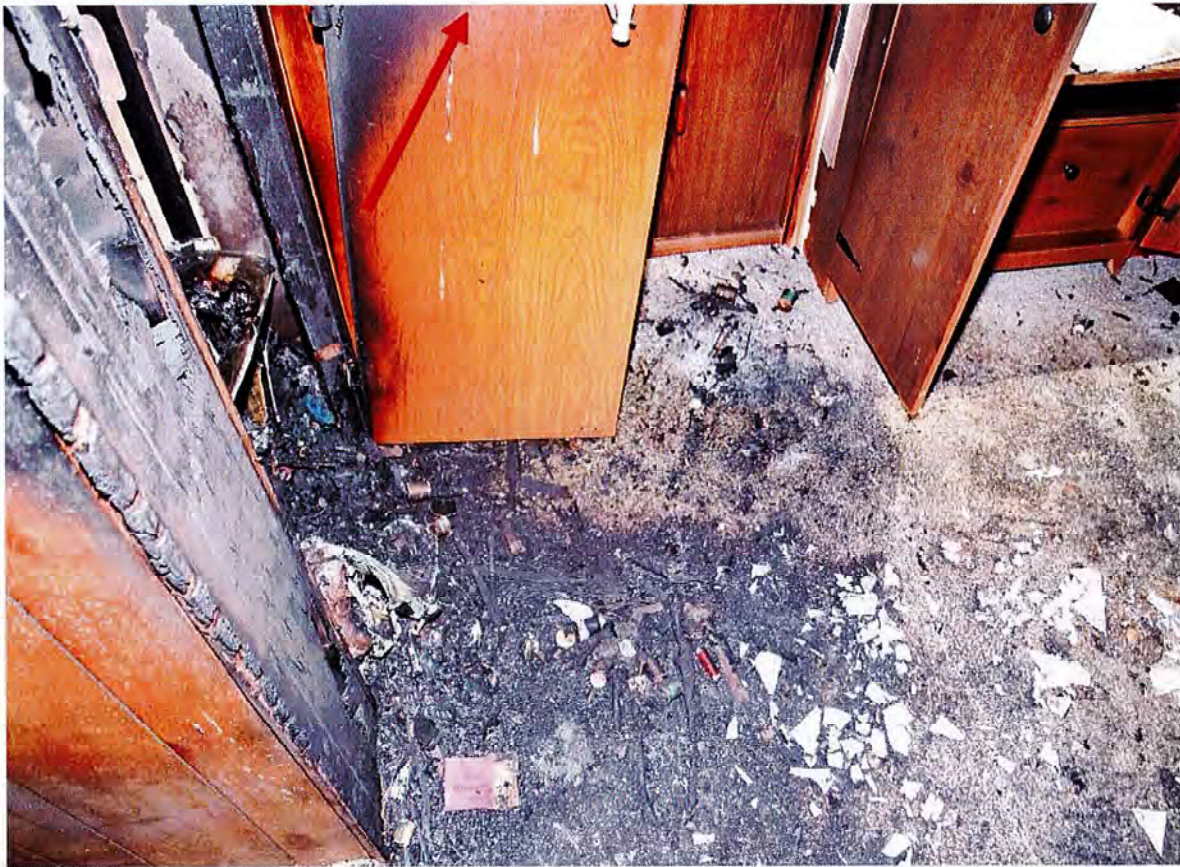
Figure 24 shows a photograph of the closet door with soot and smoke deposition on it, highlighting the direction of fire movement. This fire pattern is also consistent with the fire spreading from the closet to the rest of the room, as noted by Mr. Karasinski.<sup>64</sup>

Figure 24. Photograph of the area near the closet. The red line annotated by Exponent shows that the direction of soot and smoke deposition is consistent with fire movement from the closet to the office.<sup>65</sup>

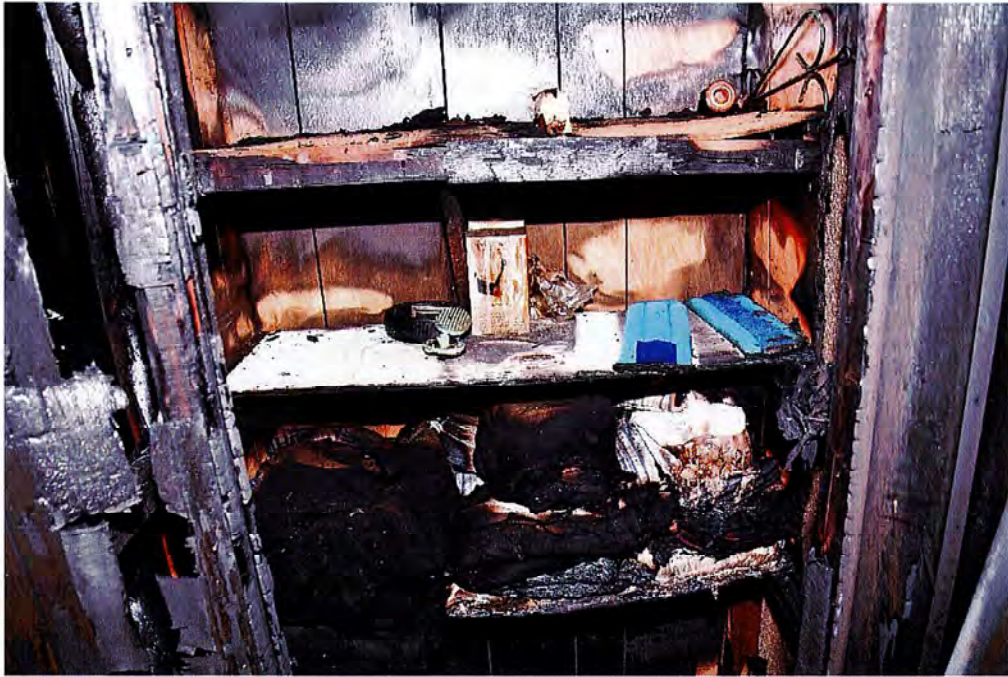
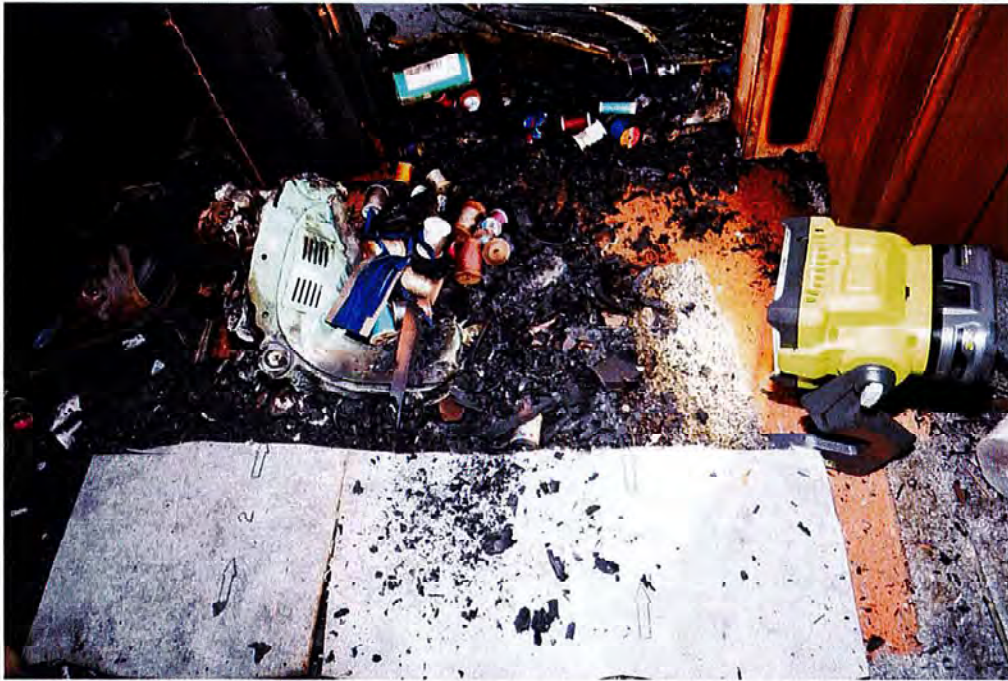
As highlighted in the previous section, it is probable that the fire originated in the office closet. Therefore, it is likely the case that first fuel for the fire was an item present in the office closet. Figure 25 and Figure 26 show photographs of some of the items in the closet that appear to be burned fuel and might be hard to identify. Some of that fuel might include clothing, as reported in the fire investigation form,<sup>66</sup> and bedding materials as Ms. Marcellin testified were in the office closet.<sup>67</sup> Other material found in the hallway, reported to have originally been stored in the office closet, included an LED lamp, a heated blanket, and an unidentifiable electrical item.<sup>68</sup>

Figure 25. Photograph of some of the items present in the office closet, some of which were consumed by the fire.<sup>69</sup>

Figure 26. Photograph of the debris from the office closet.<sup>70</sup>

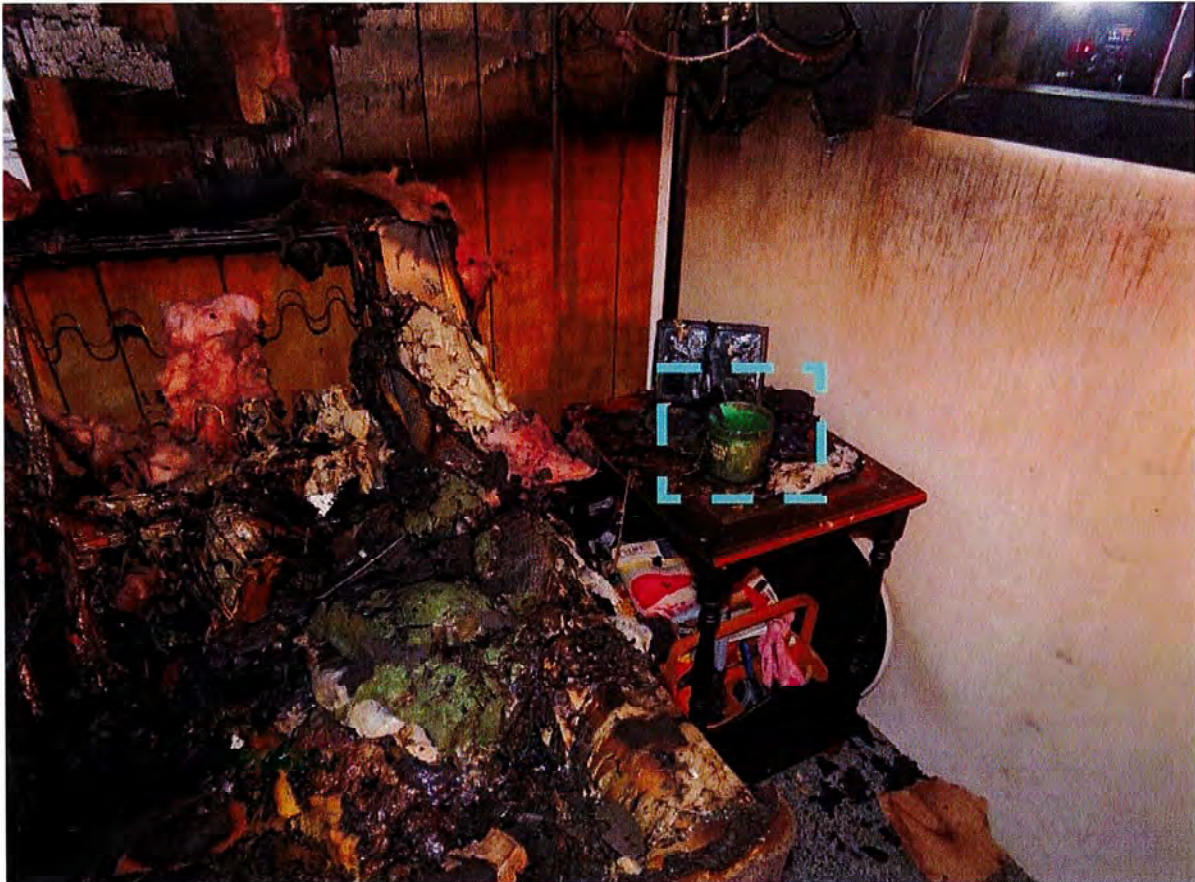
Other potential ignition sources could have started a fire in the couch. For instance, Allegany fire investigators documented a candle on the table next to the couch as shown in Figure 27. This indicates that candles and open flames are sometimes used near the couch.

Figure 27. Photograph showing a candle on the table next to the couch. The light blue box annotated by Exponent highlights the candle location.<sup>76</sup>

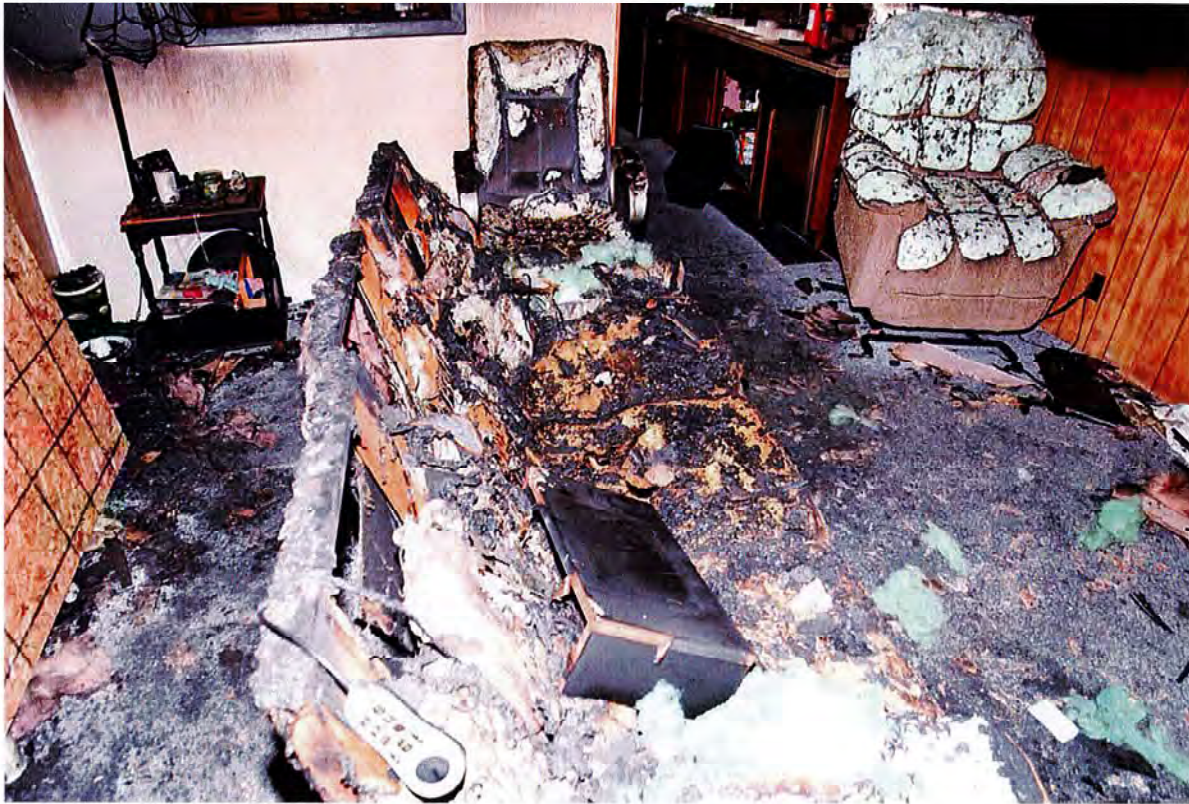
As highlighted in Figure 28 the living room couch experienced significant damage and is the lowest area of burn in the living room. The couch reportedly had electric power, including heating coils. The Allegany County fire investigation team indicated that they verified that the

relevant to note that a nearby electric chair shows significantly less thermal damage and mass loss than the couch, as illustrated in Figure 28, below. Of further relevance is the elevated position of the chair, which would have put it in closer proximity to the hot gas layer and the radiant heat coming from it. The greater damage to the couch than the chair would be consistent with the couch being a source of fire, rather than both objects being ignited by being exposed to thermal radiation.

Figure 28. Photograph of electric couch and chair in the living room.<sup>77</sup>

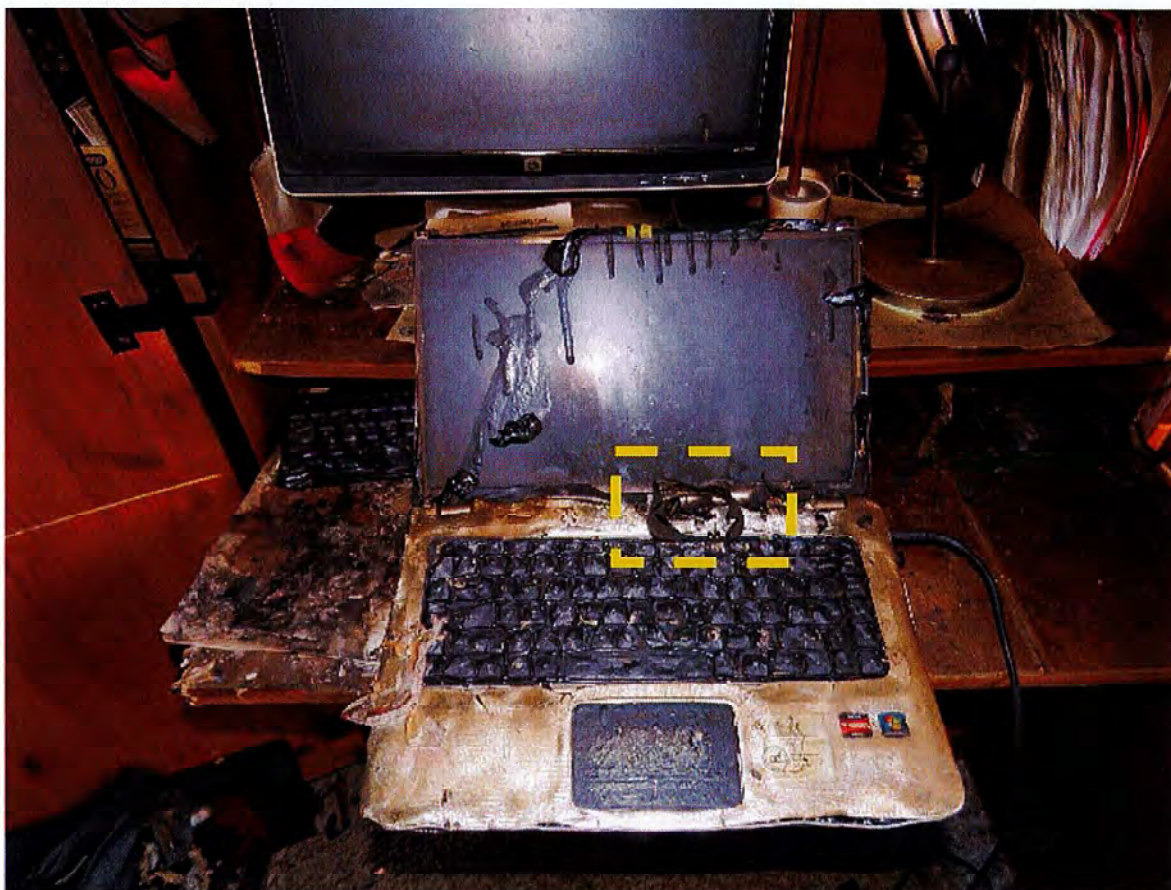
Figure 30 displays a photograph of the incident notebook, the 2011 HP Pavilion. The notebook's keyboard and the surrounding area show heat damage consistent with radiant heat exposure from the hot gas layer in the office. The yellow box highlights a section of the notebook that is damaged and open around the battery pack area; this could have occurred due to a combination of radiant heat from the hot ceiling layer and thermal runaway of cells. The notebook screen has some resolidified material on it, consistent with softening of plastic around the notebook screen due to radiant heating.

Figure 30. Photograph of the incident notebook. The yellow box annotated by Exponent highlights the ruptured area in the notebook likely where the cells escaped from.<sup>87</sup>

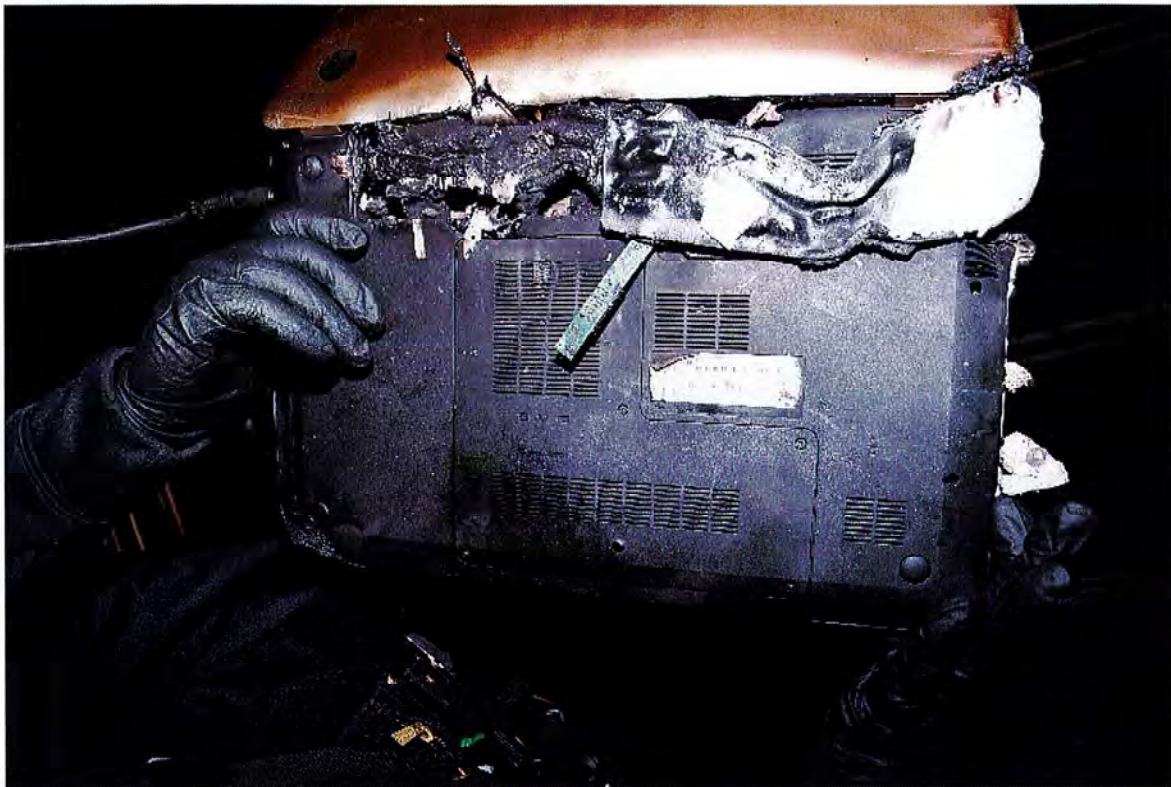
Figure 31 shows a photograph of the bottom part of the notebook. The section of the notebook close to the battery pack appears to have experienced heat damage and softening due to the cells going into thermal runaway. However, it is unlikely that this localized damage initiated the fire, as will be discussed later in this section.

Figure 31. Photograph of the bottom of the incident notebook highlighting damage close to where the battery pack is located.<sup>88</sup>

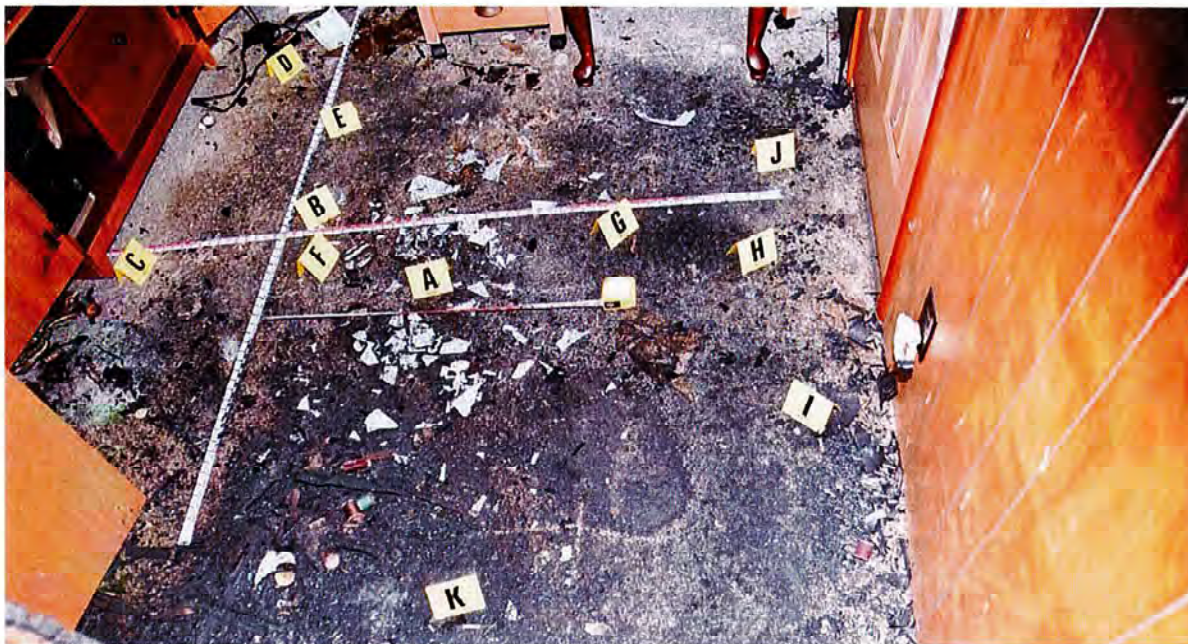
As previously stated, thermal runaway events can result in the ejection of hot gases and materials. The debris resulting from this thermal runaway event are pictured in Figure 32 below.

Figure 32. Photograph of the office floor with evidence labels for battery debris.<sup>95</sup>
